**Submitted to the
Town of Dedham, Massachusetts**

GLENWAY/HAMILTON AVENUE STUDY AREA

Final Report

April 2004

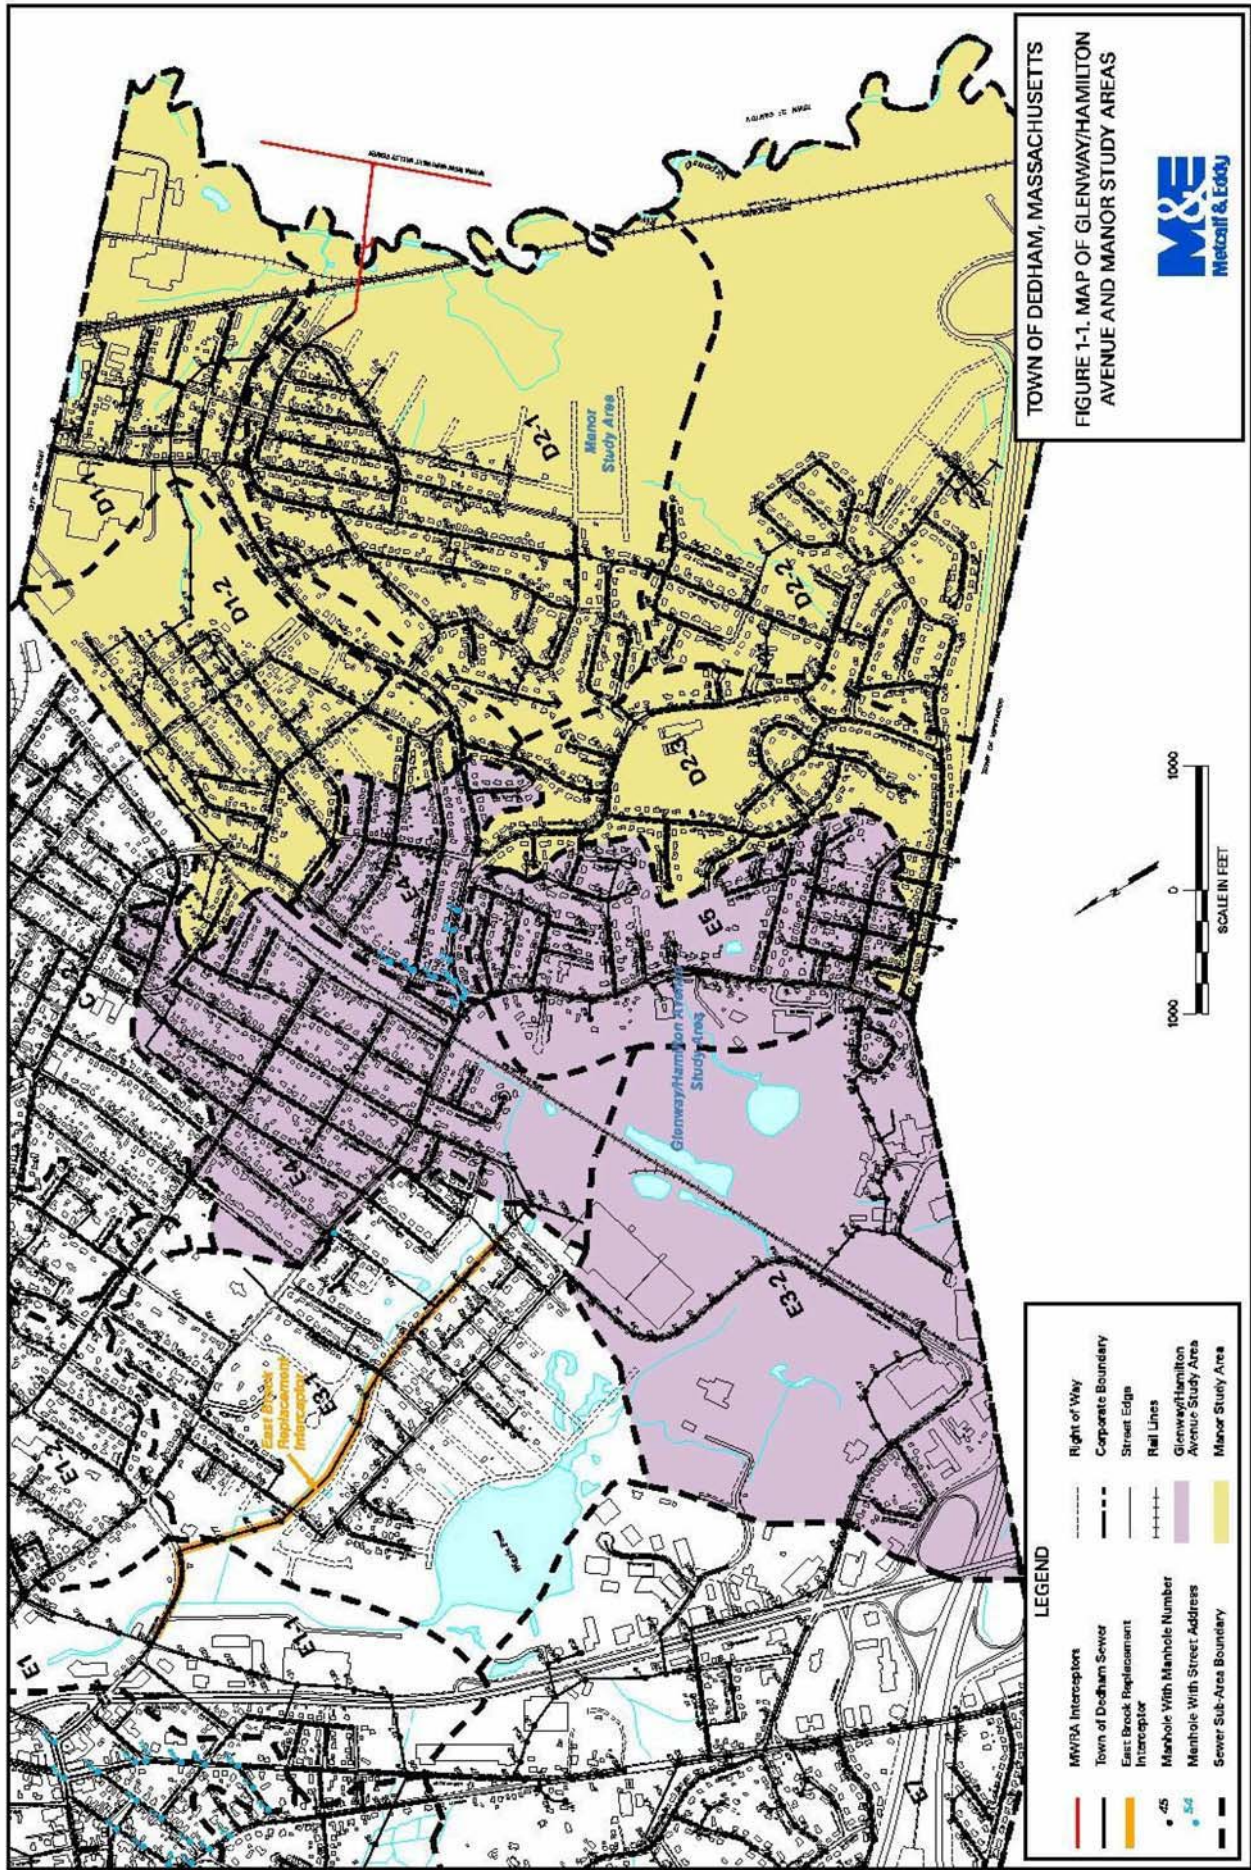
As shown on Figure 1-1, the Glenway/Hamilton Avenue study area is located in the southern section of Dedham and is comprised of sewer subareas E3-2, E4-1, E4-2, and E5. The sewers in

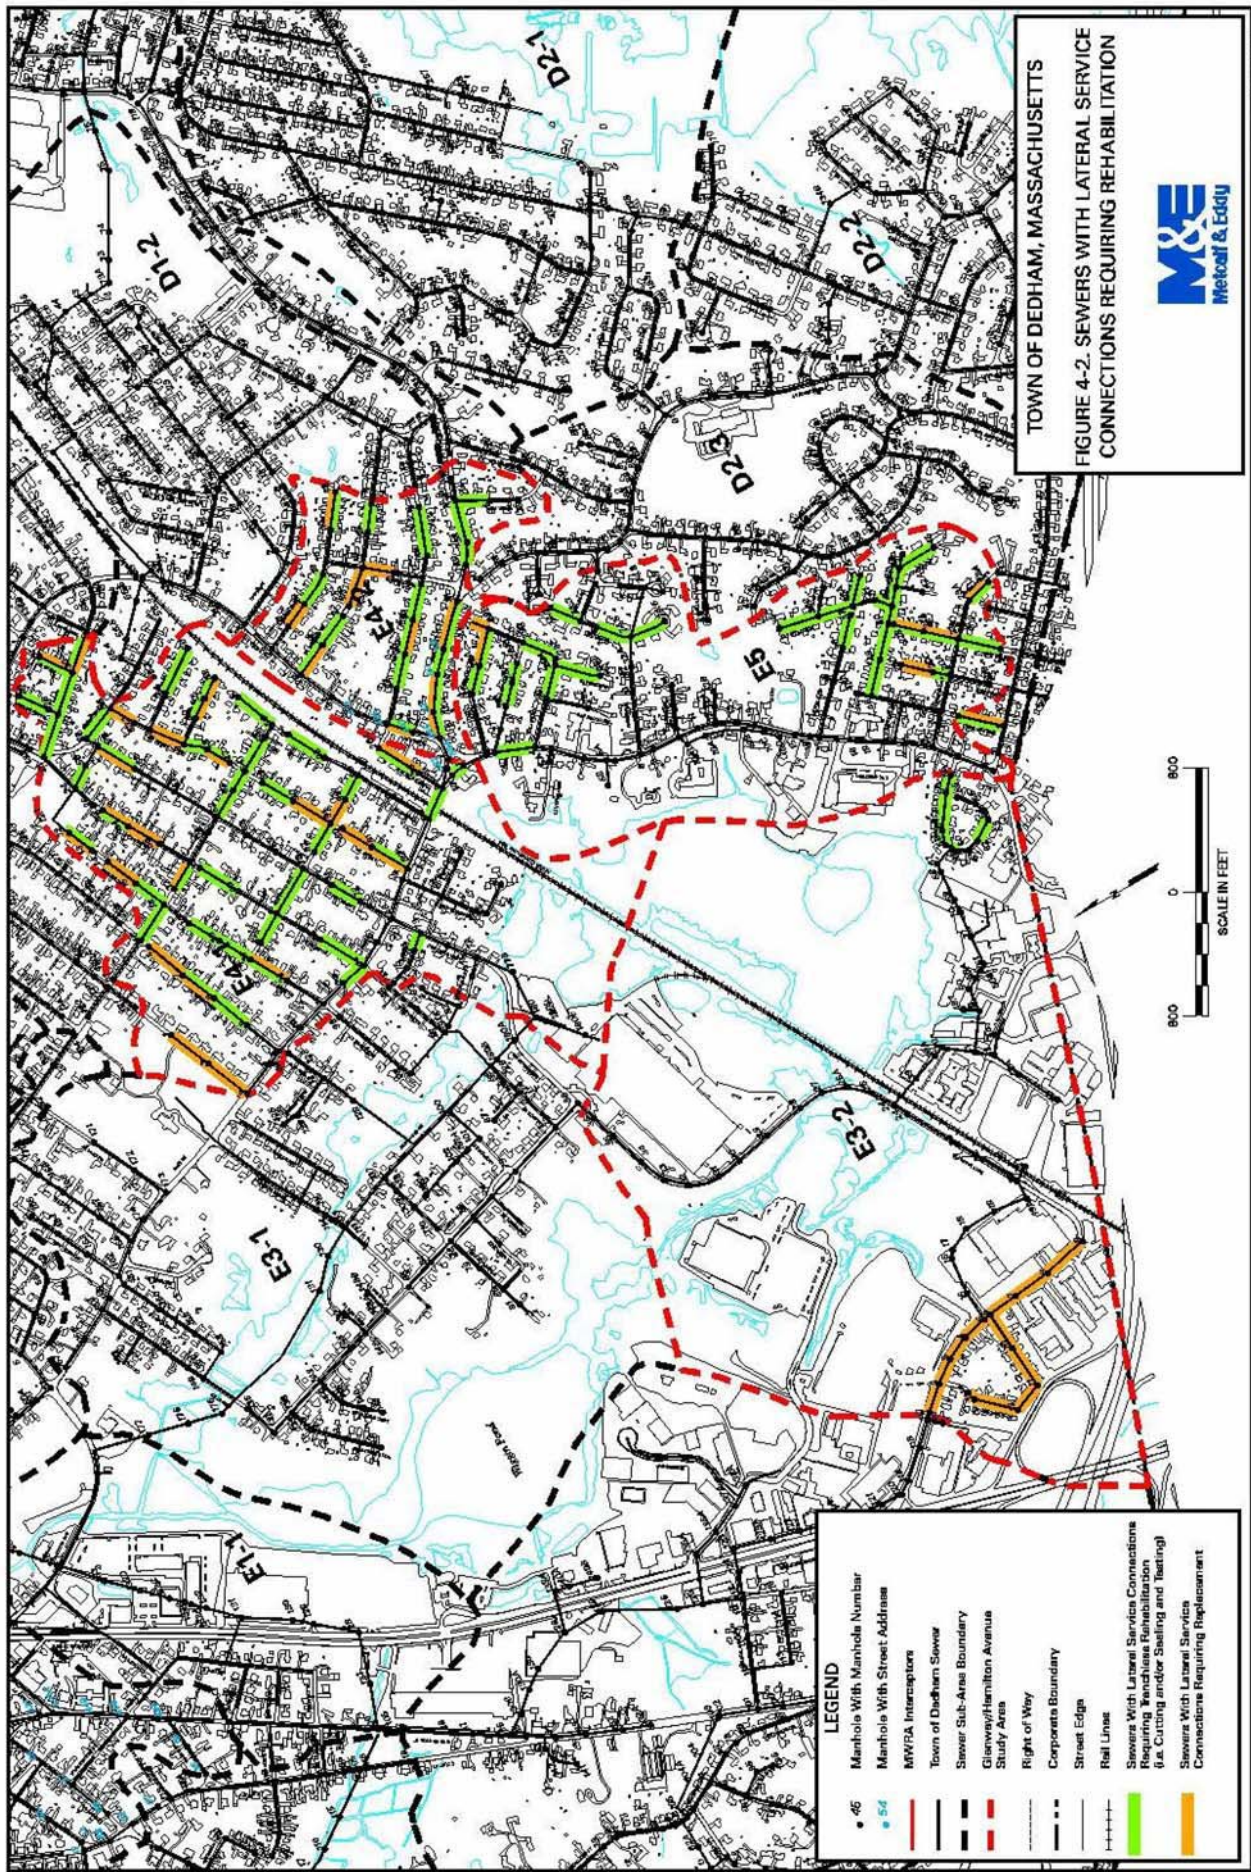
As summarized in Section Three of this report, there are two areas that are subject to flow related problems that are likely due to the existing sewers being constructed with less than minimal slope and/or depth of cover. The first area is located in subarea E3-2, and includes the sewer on Rustcraft Road between Elm Street and the East Brook Replacement Interceptor (EBRI) at McKinley Avenue. The second area is located in subareas E4-1 and E5, and includes the sewers on East Street and Rustcraft Road between Route 95 and the terminus of the EBRI. The latter area also includes the sewers on Glenway and Hamilton Avenue. Specific recommendations to address the capacity problems in these areas are discussed later in this section.

New replacement or relief sewers would be constructed to provide additional capacity to convey peak flows during wet weather conditions. These sewers would be sized accordingly, and designed to meet minimum criteria established for pipe slope and depth of cover. However, when the upstream and downstream inverts are fixed (i.e. no drop inlet, no end manhole, etc.), replacement with a larger sized pipe at the same elevation may not necessarily eliminate the problem(s). As a result, there may be existing low-lying areas where consideration would be given to the installation of a pump station and force main in lieu of a gravity system that may already exist. However, this determination would be based on evaluation of site specific conditions and comparison of both capital and annual O&M costs.
